# Reaction Control System Thruster Cracking Consultation: NASA Engineering and Safety Center (NESC) Materials Super Problem Resolution Team (SPRT) Findings

Rebecca A. MacKay  
Glenn Research Center, Cleveland, Ohio

The shuttle orbiter's reaction control system (RCS) primary thruster serial number (S/N) 120 was found to contain cracks in the counter bores and relief radius after a chamber repair and rejuvenation was performed in April 2004. Relief radius cracking had been observed in the 1970s and 1980s in seven thrusters prior to flight; however, counter bore cracking had never been seen previously in RCS thrusters. Members of the Materials Super Problem Resolution Team (SPRT) of the NASA Engineering and Safety Center (NESC) conducted a detailed review of the relevant literature and of the documentation from the previous RCS thruster failure analyses of the 1980s. It was concluded from the review that the previous failure analyses lacked sufficient documentation to support the conclusions that stress corrosion cracking or hot-salt cracking was the root cause of the thruster cracking and lacked reliable inspection controls to prevent cracked thrusters from entering the fleet. The

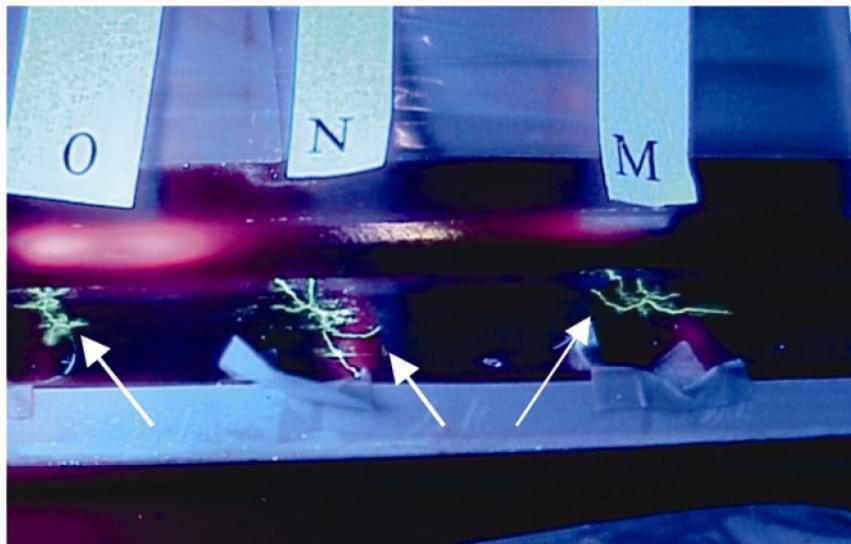
Figure 2.—Cracks in three counter bores are indicated by arrows (from ref. 4, reprinted with permission from Boeing). Counter bores from holes M, N, and O are shown.

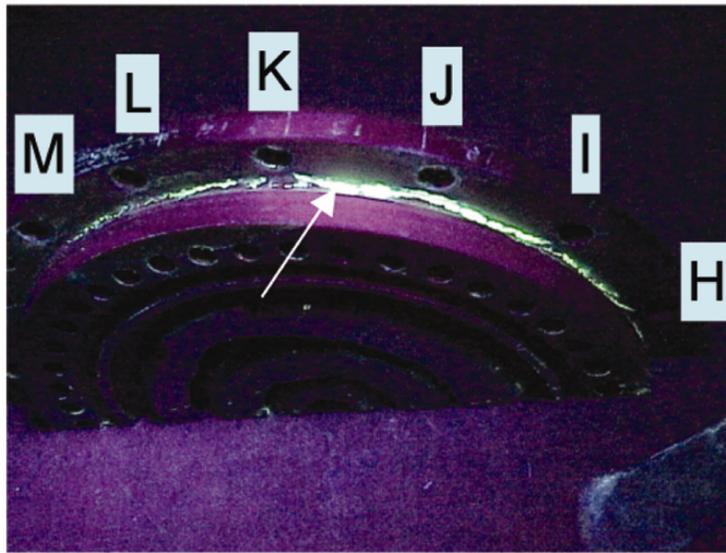
Figure 3.—Relief radius cracking is evident over a large fraction of the injector circumference (from ref. 4, reprinted with permission from Boeing) near holes H through M.

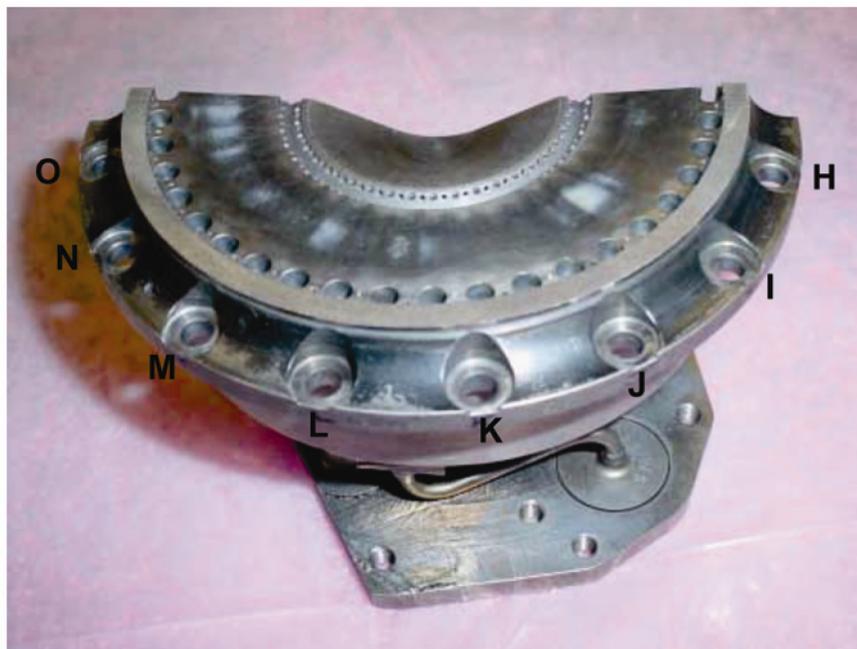
S/N 120 was submitted in its entirety to the M&P organization at Boeing Huntington Beach (HB) for failure analysis in June 2004. The portion of S/N 120 that was set aside for destructive analysis is shown in figure 4 (ref. 4); the remainder of the injector was left intact with the combustion chamber and was used in nondestructive evaluation (NDE) development efforts. The Boeing HB failure analysis (ref. 8) concluded that the injector cracking was intergranular and that the overall appearance of the cracking in S/N 120 was similar to what was described in the failure analyses conducted in the early 1980s. The presence of carbon, oxygen, and fluorine was found on the fracture surfaces, although the age of the cracks could not be determined. The chemical analysis, grain size, and hardness of the bulk material (refs. 4 and 8) met the original material specifications, which are given in table I (ref. 9). In addition, no evidence of overload by ductile rupture or of fatigue rupture was found (ref. 4).

Figure 4.—Portion of S/N 120 that was set aside for failure analysis. Counter bores and bolt holes are labeled H through O (from ref. 4, reprinted with permission from Boeing).

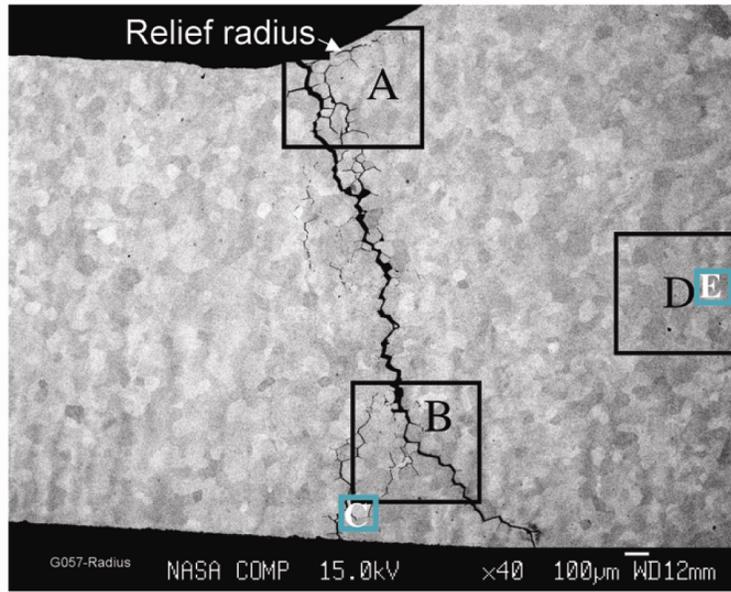
A large relief radius crack near bolt hole J was selected for initial microprobe examination, and the specific areas (A to E) examined along the crack and away from the crack are indicated in figure 5. The full depth of the intergranular crack in this location is not known because the tip of the major crack was not contained within the cut section provided by Boeing HB. Area dot maps were obtained at magnifications of 200× and 1000× near the relief radius surface (area A), as well as ~1.8 mm (0.07 in.) away (areas B and C) from the surface, in an effort to determine if any qualitative differences in the distributions of elements were present as a function of distance from the relief radius surface. Uncracked areas (near D and E) were also examined to detect the presence of precipitates or higher concentrations of solutes, if any, along grain boundaries away from cracks. Such features, if present, would indicate a predisposition to SCC or hot-salt cracking.

Figure 5.—Large crack in relief radius near hole J is shown. Areas A through E were selected for microprobe analyses to examine cracked areas near (A) and away (B and C) from the surface, as well as uncracked areas (D and E). Area dot maps were obtained at magnifications of 200× in locations A, B, and D and at 1000× in locations C and E.

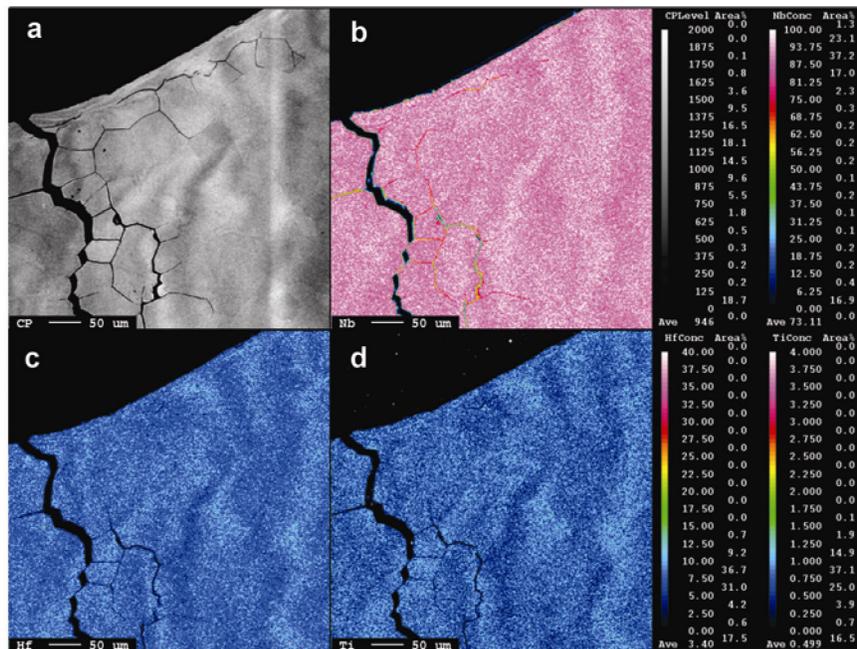
Figure 6(a) shows a backscattered electron (BSE) image of the crack near the surface of the relief radius. BSE imaging clearly delineates the cracks and reveals atomic number differences within the microstructure. The major cracks follow the grain boundaries in the material; finer cracks are also observed to run nearly parallel to the relief radius surface along the grain boundaries beneath the deformed layer from machining. Figures 6(b) to (d) show the dot maps for niobium, hafnium, and titanium, respectively, for the same field of view. The qualitative concentration levels are given for each element in the keys to the right of the figure; the brighter areas in the dot maps indicate more elevated levels of each respective element. Careful examination of figure 6(b) shows that the niobium levels lining the surfaces of the cracks are reduced from the levels within the general microstructure; this result is from the niobium being tied up in the oxide on the crack surfaces. Hafnium and titanium are not evident within

the cracks (figs. 6(c) to (d)). Figures 6(b) to (d) also show that the grain boundaries in uncracked areas are not delineated by the major elements (niobium, hafnium, and titanium). The most prominent feature in figures 6(a) to (d) is the macroscopic banding that occurs for these major elements. It is apparent that slightly elevated concentrations of hafnium and titanium reside in bands wherever the niobium is somewhat leaner, and vice versa. This was consistently observed in other areas of the injector and represents the residual forged macrostructure.

Figure 6.—Microprobe dot maps showing relief radius crack near hole J at surface for location A in figure 5. (a) Backscattered electron image and levels of (b) niobium, (c) hafnium, and (d) titanium. Brighter areas in b, c, and d indicate higher concentrations of each element; qualitative levels are shown in the keys on the right.

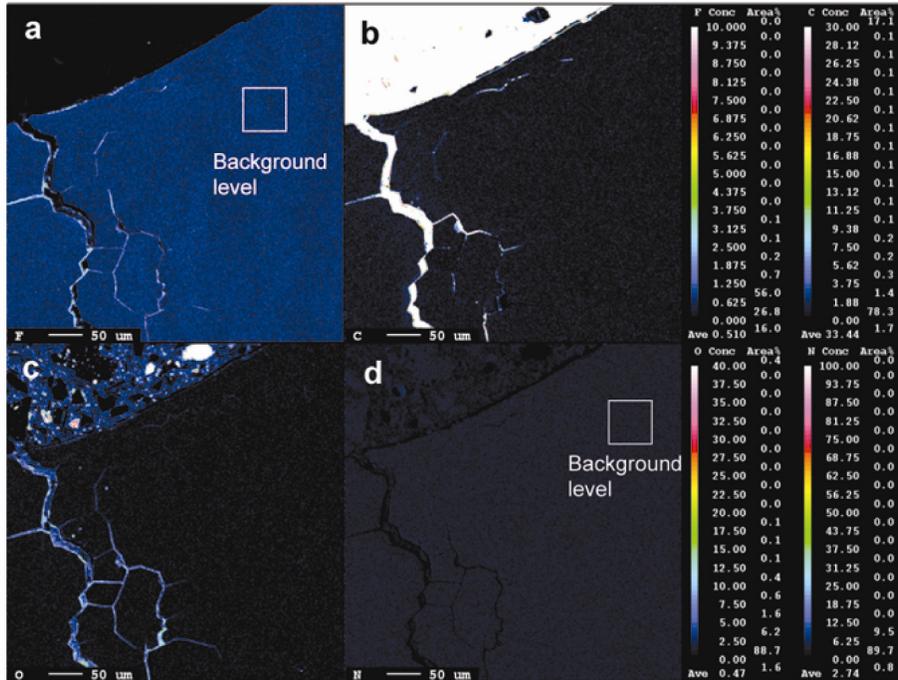
Figure 7 represents the same near-surface area as that presented in figure 6 and contains dot maps for fluorine, carbon, oxygen, and nitrogen. These elements were examined to confirm the presence of elevated levels of fluorine, carbon, and oxygen that were found on the crack surfaces in the prior failure analysis (refs. 4 and 8) and also to examine for the presence of these elements along grain boundaries in uncracked regions, since oxygen and nitrogen are known to cause embrittlement in niobium materials (refs. 11, 12, 14, 16, 18, and 24). Hydrogen cannot be detected by the electron microprobe. Figure 7(a) shows that fluorine is present along the cracked intergranular surfaces and along part of the relief radius surface, as indicated by the bright blue-green levels. Carbon and oxygen are more readily discernable within the crack (figs. 7(b) and (c)). Some of these levels of carbon and oxygen may have been enhanced by the limited infiltration of the mounting medium from the relief radius surface, although carbon and oxygen are also elevated near the crack tip, where infiltration of the mounting medium did not occur. Thus, the elevated levels of carbon and oxygen on the intergranular fracture surfaces in these areas of S/N 120 are consistent with previously reported scanning Auger results (refs. 4 and 8). Elevated levels of nitrogen were typically not apparent along the cracks (fig. 7(d)). It is important to note that the microprobe dot maps do not indicate a presence of fluorine, carbon, oxygen, and nitrogen outside the cracks, since no elevated levels of these elements were observed outside the cracks that were above background levels. Thus, no local segregation of fluorine, carbon, oxygen, and nitrogen was present outside the cracks. Dot maps were also obtained for zirconium, tantalum, and tungsten; these elements were not found within the cracks and were not found to be segregated within the uncracked microstructure.

Figure 7.—Microprobe dot maps showing relief radius crack near hole J at the surface (location A) and levels of (a) fluorine, (b) carbon, (c) oxygen, and (d) nitrogen. Brighter areas indicate higher concentrations of each element; qualitative levels are shown in the keys on the right.

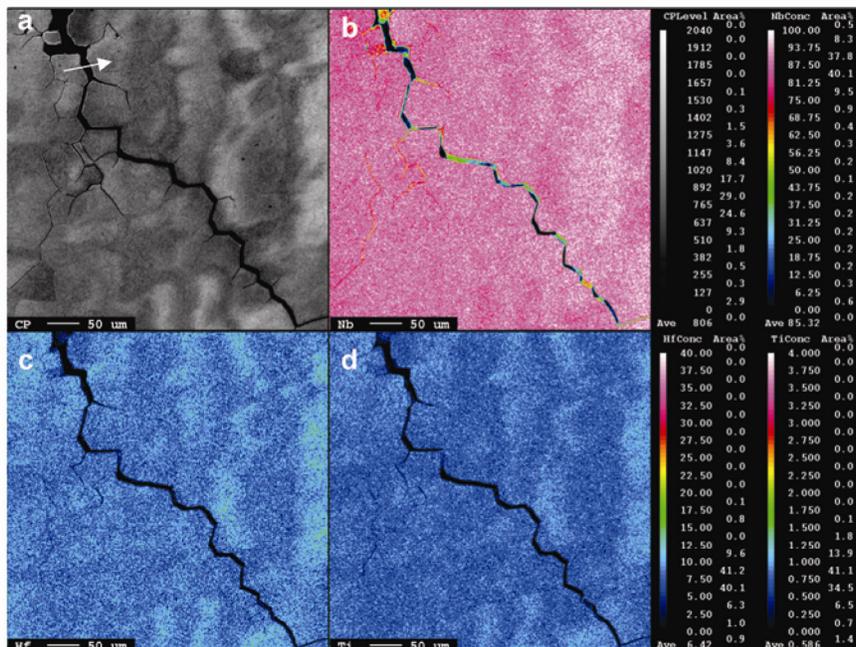
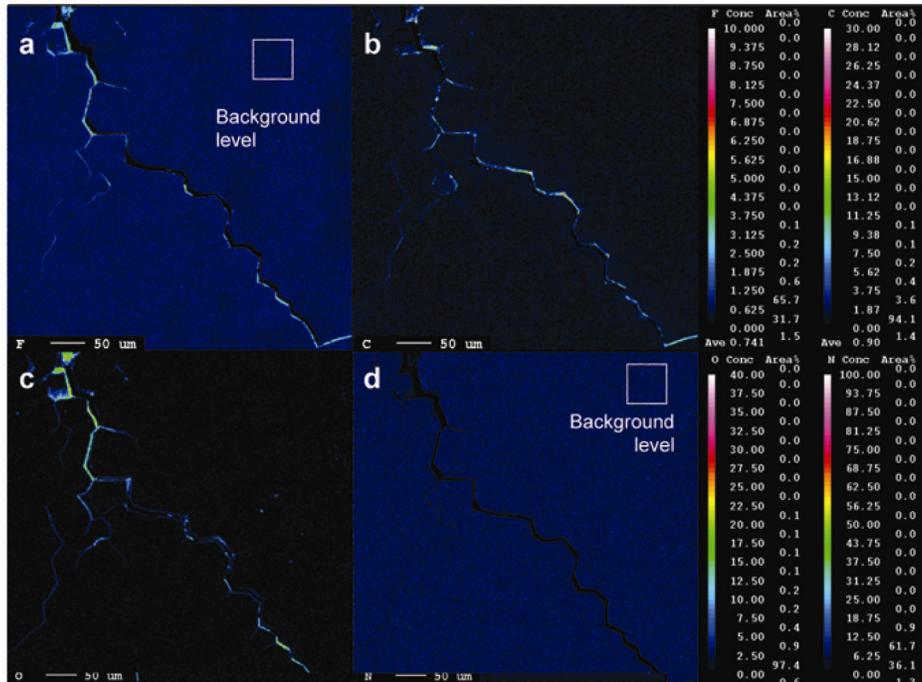
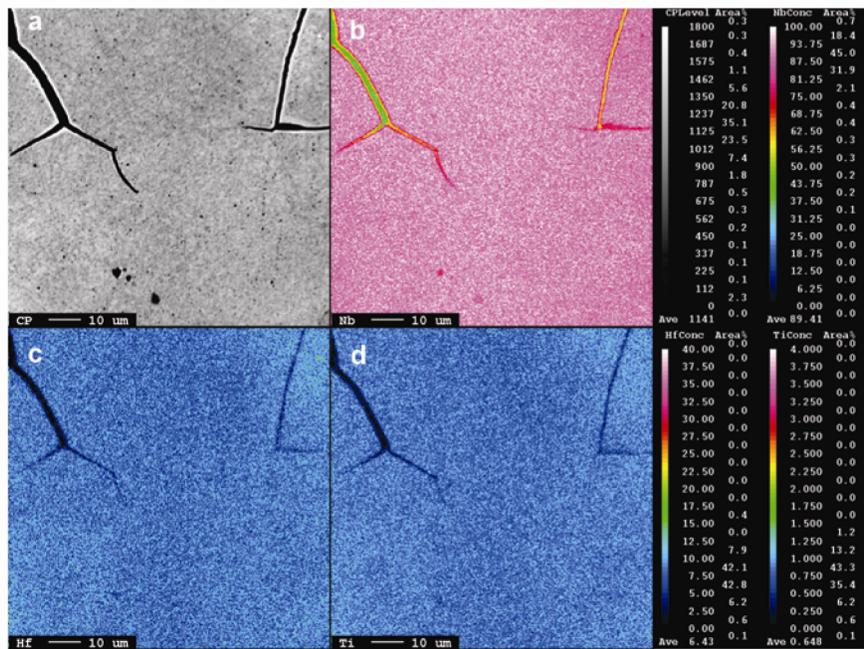
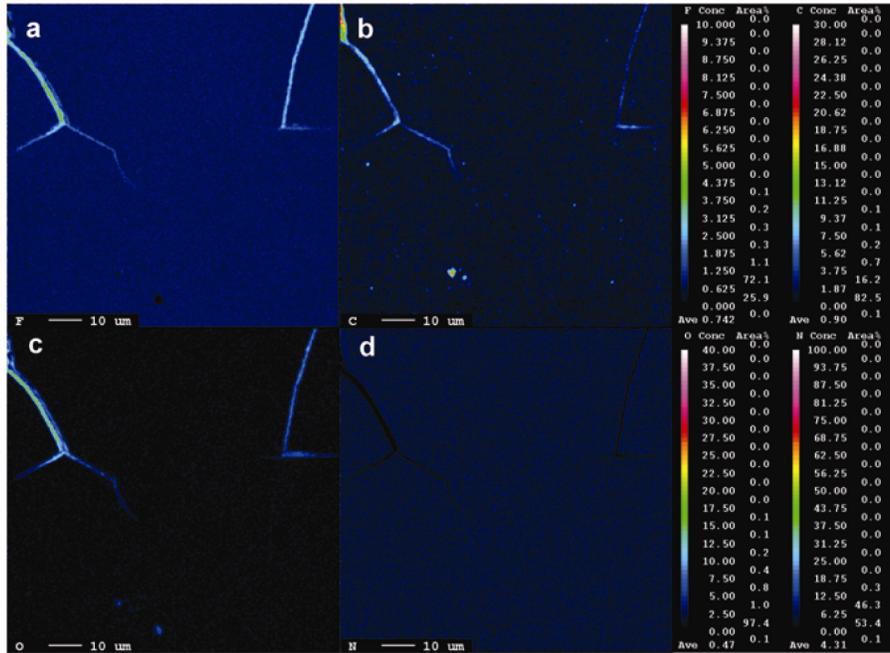
Similar results were obtained from regions further in from the machined surfaces along the main crack and at terminations of side branches (figs. 8 to 11). Again, niobium levels within the cracks were reduced when compared to the general microstructure, which is the result of niobium oxide on the crack surfaces. Hafnium and titanium were again not found within the cracks. Fluorine, carbon, and oxygen were clearly present along the intergranular cracks to the crack terminations, with oxygen being observed as a continuous film along the entire crack surface. Fluorine and carbon were not

consistently observed as a continuous film along the intergranular cracks.

Figure 8.—Microprobe dot maps showing relief radius crack near hole J at location B, approximately 1.8 mm (0.07 in.) away from surface. (a) Backscattered electron image and levels of (b) niobium, (c) hafnium, and (d) titanium. Brighter areas indicate higher concentrations of each element. Qualitative levels are shown in the keys on the right. Subsequent line scans were performed and typical orientations of line scan with respect to the crack direction is indicated by arrow in (a).

Figure 9.—Microprobe dot maps showing relief radius crack near hole J at location B, approximately 1.8 mm (0.07 in.) away from surface. Levels of (a) fluorine, (b) carbon, (c) oxygen, and (d) nitrogen. Brighter areas indicate higher concentrations of each element. Qualitative levels are shown in the keys on the right.

Figure 10.—Microprobe dot maps showing terminations of branches of relief radius crack near hole J at location C approximately 1.8 mm (0.07 in.) away from relief radius surface. (a) Backscattered electron image and levels of (b) niobium, (c) hafnium, and (d) titanium. Brighter areas indicate higher concentrations of each element. Qualitative levels are shown in the keys on the right.

Figure 11.—Microprobe dot maps showing terminations of branches of relief radius crack near hole J at location C, approximately 1.8 mm (0.07 in.) away from relief radius surface. Levels of (a) fluorine, (b) carbon, (c) oxygen, and (d) nitrogen. Brighter areas indicate higher concentrations of each element. Qualitative levels are shown in the keys on the right.

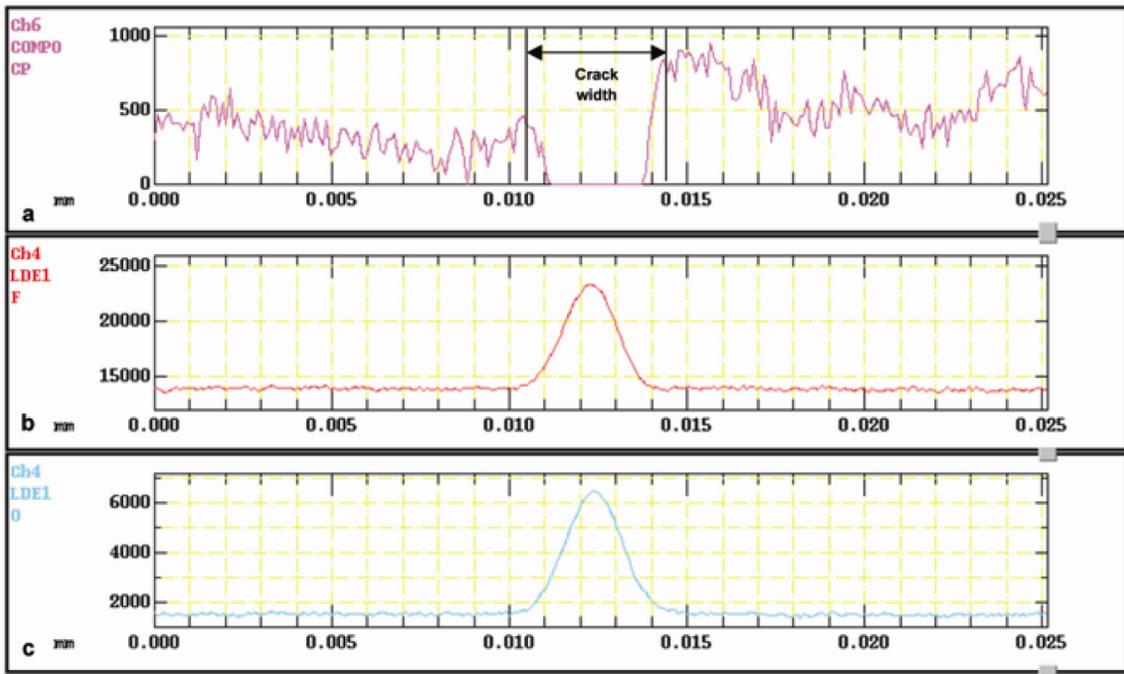
Microprobe line scans were also conducted across relief radius cracks. Line scans provide counts as a function of distance for each element selected and are more sensitive to small variations in chemistry than microprobe dot maps. The line scans were performed normal to the intergranular cracks in polished cross sections so that data could be obtained from within the crack itself and from material just outside of the crack. An example of the position of a typical line scan is indicated by the white arrow superimposed in figure 8(a), and figure 12 provides an example of typical data obtained from such a line scan. Figure 12(a) provides gray scale image counts across the crack that was analyzed; the crack width is indicated in this figure where the gray scale counts drop off precipitously to zero. Figures 12(b) and (c) represent the analyzed data for fluorine and oxygen, respectively, as a function of distance across the intergranular crack. It may be seen that the number of counts for each element increases significantly within the crack relative to background levels. These line scans confirm the dot map data that indicate that higher concentrations of fluorine and oxygen were present within the cracks and that these elements did not extend beyond the cracks into the parent material.

Figure 12.—Line scan analyses of intergranular crack in S/N 120 showing counts versus distance in millimeters for (a) gray scale, backscattered electron image with approximate crack width delineated; (b) fluorine; and (c) oxygen.

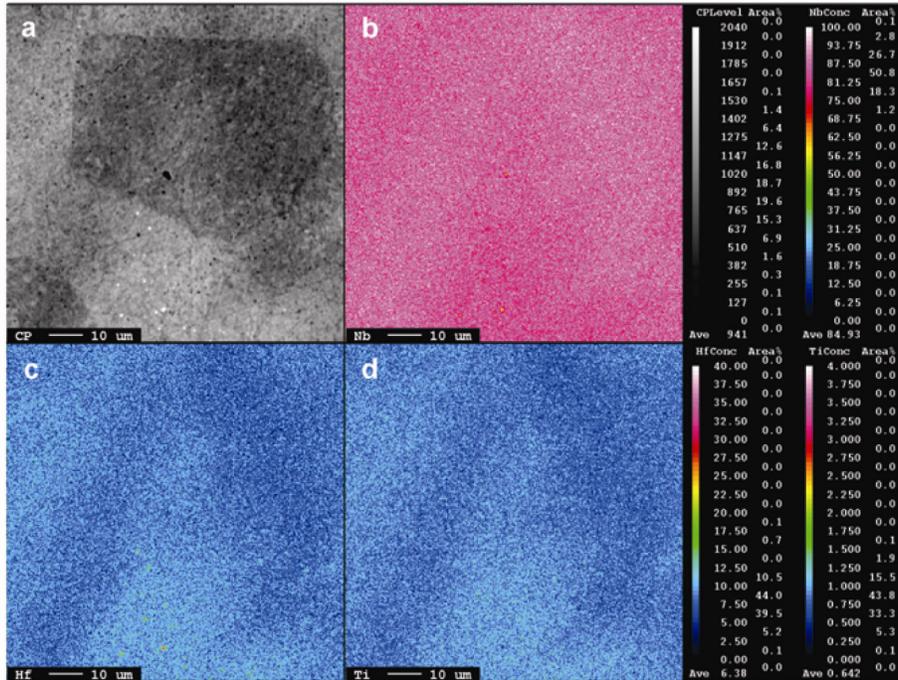
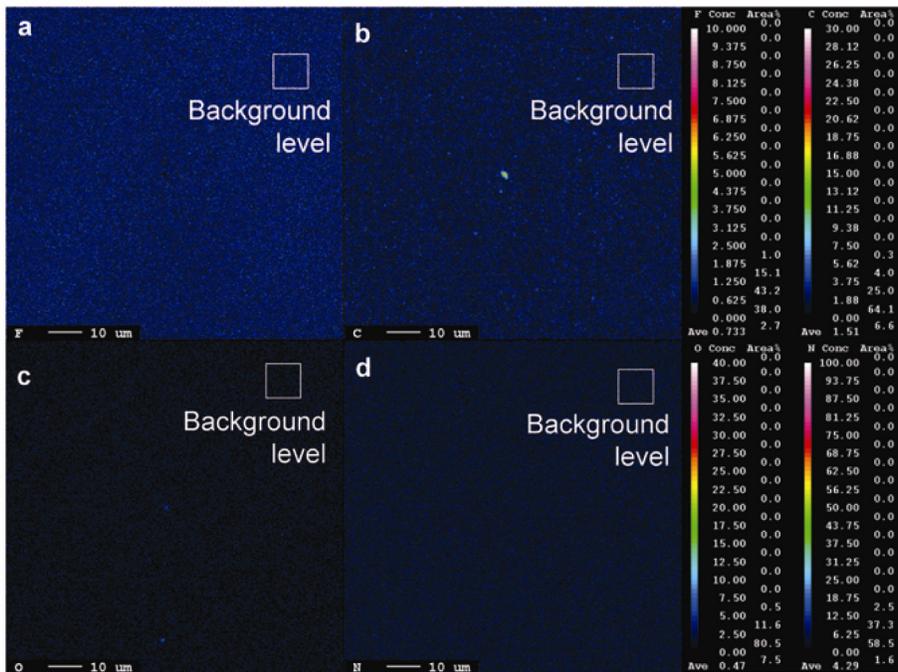
Microprobe dot maps were also obtained in regions far removed from the intergranular cracks to examine the material for the presence of any precipitates or higher concentrations of solutes. Features such as these would indicate that the C-103 may be predisposed to SCC or hot-salt cracking. An example of an uncracked region away from the relief radius crack is shown in figure 13. The BSE image in figure 13(a) delineates several grains in the field of view at a magnification of 1000 $\times$ . No precipitates or elevated levels of the major elements are evident on the grain boundaries, although a few hafnium oxides are observed within some of the grains. The banded macrostructure is visible, particularly in figures 13(c) to (d), and the hafnium oxides are observed within a hafnium-rich band. Dot maps of fluorine, carbon, oxygen, and nitrogen in figure 14 also reveal no elevated concentrations of these elements above background levels. These results were confirmed in other uncracked regions of S/N 120 near bolt holes H, K, and M.

Figure 13.—Microprobe dot maps showing region away from relief radius crack near hole J at location E. (a) Backscattered electron image and levels of (b) niobium, (c) hafnium, and (d) titanium. Brighter areas indicate higher concentrations of each element. Qualitative levels are shown in the keys on the right.

Figure 14.—Microprobe dot maps showing region away from relief radius crack near hole J at location E. Levels of (a) fluorine, (b) carbon, (c) oxygen, and (d) nitrogen. Brighter areas indicate higher concentrations of each element. Qualitative levels are shown in the keys on the right.

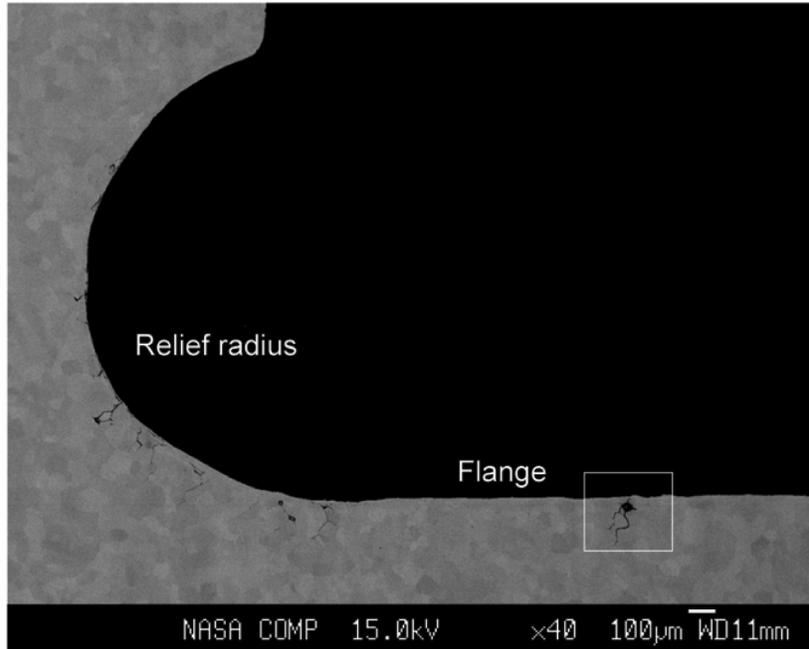
The relief radius in the vicinity of bolt hole H contained several shallow cracks, which were only up to several grains deep in from the surface (fig. 15). These cracks were located near the end of the large relief radius crack indication that was revealed by the dye penetrant inspection in figure 3 for S/N 120. A box superimposed on the image in figure 15 highlights a crack along the injector flange; microprobe analyses were performed on this area to determine if shallow cracks yielded

similar results to those obtained on deeper cracks (i.e., near hole J). The selected crack in figure 15 completely surrounded a grain which subsequently fell out during metallographic polishing. The void that was left behind enabled a unique opportunity for the analyses of broad surfaces of grain boundaries. Figures 16(a) to (d) show the BSE image for the analysis area and the dot maps for fluorine, oxygen, and carbon, respectively. It is evident from these data that high concentrations of fluorine, oxygen, and carbon were present on the broad grain boundary surfaces of the shallow crack, which is consistent with the results from the polished cross sections of the deep relief radius crack near bolt hole J. Microprobe line scans also confirmed the presence of elevated levels of fluorine and oxygen within the shallow intergranular cracks.

Figure 15.—Backscattered electron image showing region in vicinity of relief radius near bolt hole H. Several shallow, intergranular cracks are evident near the machined surface of the relief radius and injector flange. Area for dot mapping is indicated by the white box.

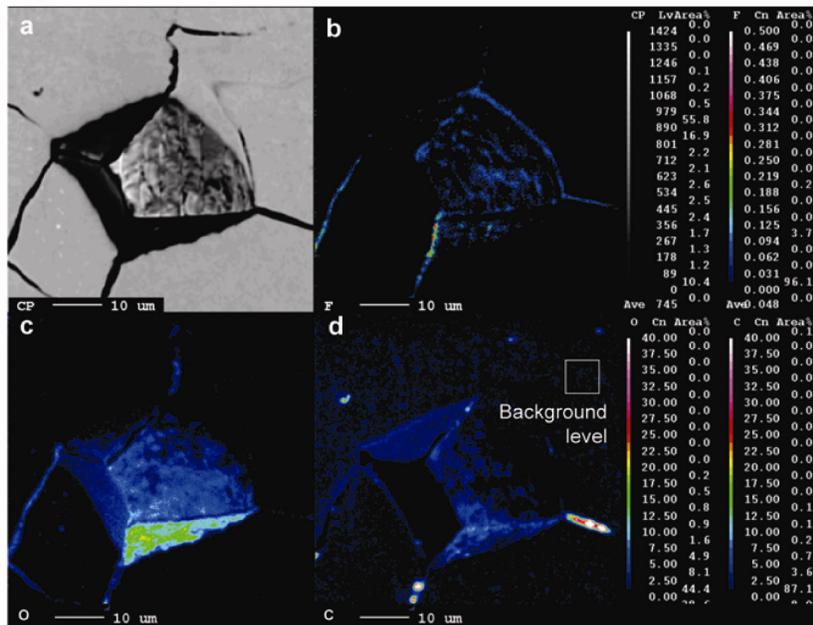
Figure 16.—(a) Backscattered electron image of a cracked region on the flange near hole H. Image shows a void left behind by a grain that fell out during metallographic preparation, which enabled broad surfaces of the grain boundaries surrounding that grain to be analyzed. Microprobe dot maps are given for (b) fluorine, (c) oxygen, and (d) carbon; brighter areas indicate higher concentrations of each element. Qualitative levels are shown in the keys for each element on the right.

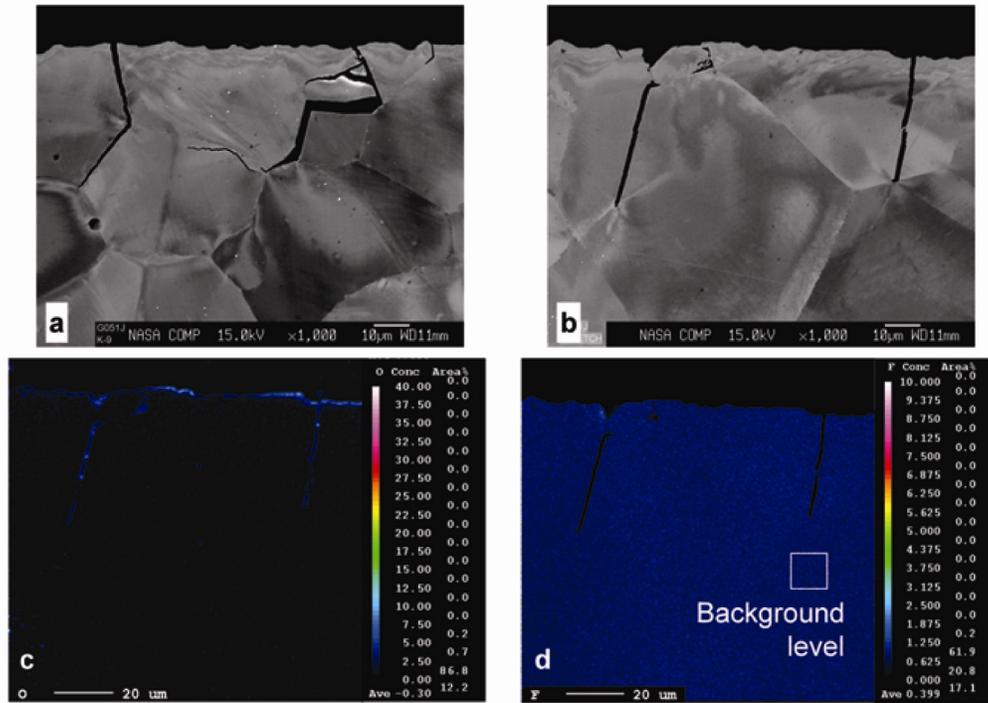
Dye penetrant results from reference 4 indicated that the counter bore of hole K was crack free. However, scanning electron microscopy revealed the presence of numerous small cracks (up to 30  $\mu\text{m}$  (0.001 in.) deep) along the counter bore surface of hole K; these were the most shallow cracks observed in S/N 120. These shallow cracks extended through the  $\sim 8$   $\mu\text{m}$  (0.0003 in.) thick, cold-worked machining layer at the surface. Some cracks proceeded inward along grain boundaries, as in figure 17(a), while other cracks proceeded inward along a transgranular path through grain interiors (fig. 17(b)). Microprobe dot maps revealed that both the intergranular and transgranular cracks were oxidized, as evidenced by the higher concentrations of oxygen along the crack surfaces, compared to that within the uncracked microstructure (fig. 17(c)). However, based on an analysis of 10 individual cracks, none of these cracks were observed to contain fluorine. An example of this is shown in figure 17(d). The reason for the consistent lack of fluorine in these shallow counter bore cracks is not known. It may be speculated that these shallow cracks did not result from exposures to HF during manufacturing but instead resulted from exposure to another source of hydrogen. A lack of fluorine was also exhibited by C-103 specimens believed to have been embrittled by hydrogen during C-ring testing (section 2.3). In contrast, the significantly deeper counter bore cracks in S/N 120 from holes M (ref. 4) and H, for example, did contain significant concentrations of fluorine, carbon, and oxygen on the intergranular crack surfaces. So in general, it may be stated that the IGC in the counter bores had similar features to those in the relief radius, except for the very shallow ( $\sim 30$   $\mu\text{m}$  (0.001 in.)) counter bore cracks.

Figure 17.—Backscattered electron images of (a) intergranular cracks and (b) transgranular cracks in the counter bore of bolt hole K. Microprobe dot maps for (c) oxygen and (d) fluorine from the field of view in (b).

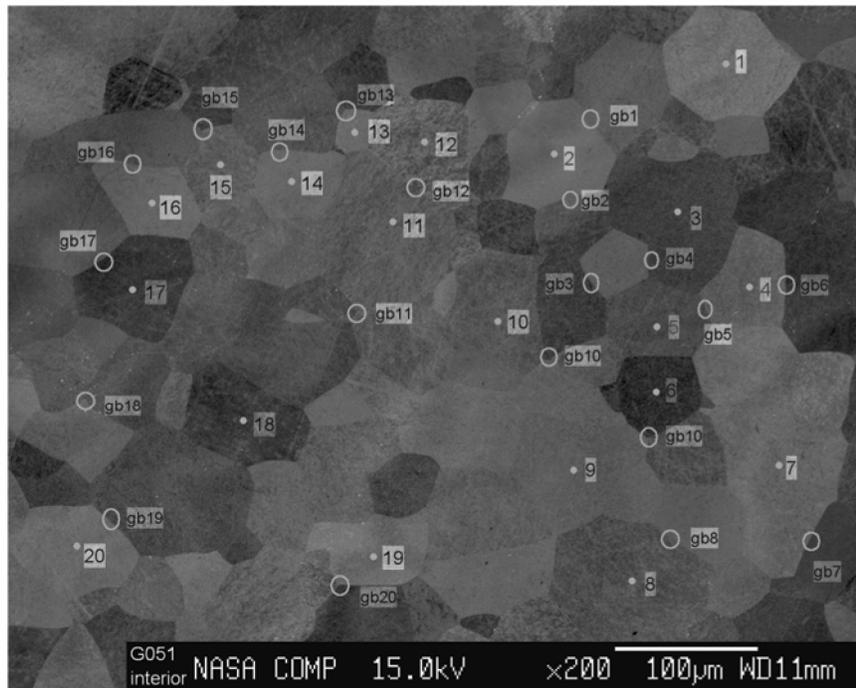
Figure 18.—Backscattered electron image of grain structure in uncracked region near counter bore of bolt hole K. Forty locations for quantitative point analyses by microprobe are indicated at grain boundaries and within grain interiors.

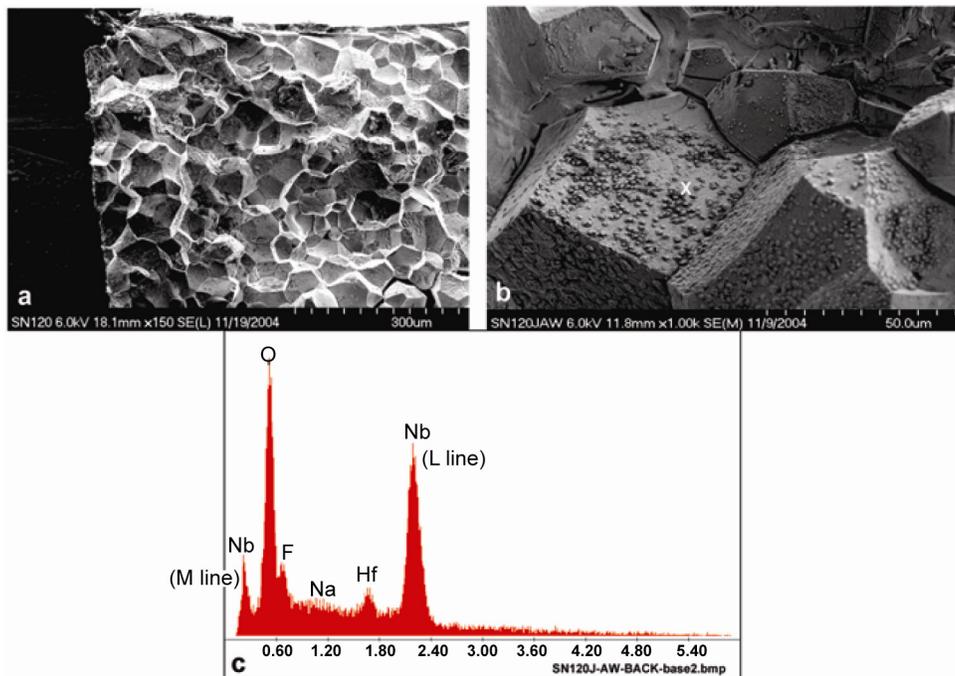
Figure 26.—Opened intergranular crack from relief radius near hole J of S/N 120: (a) low magnification view; (b) higher magnification view of crack surface showing the reaction products and grain facet analyzed (at location X) by Energy Dispersive Spectroscopy (EDS); and (c) typical EDS scan showing high O peak and presence of F peak.

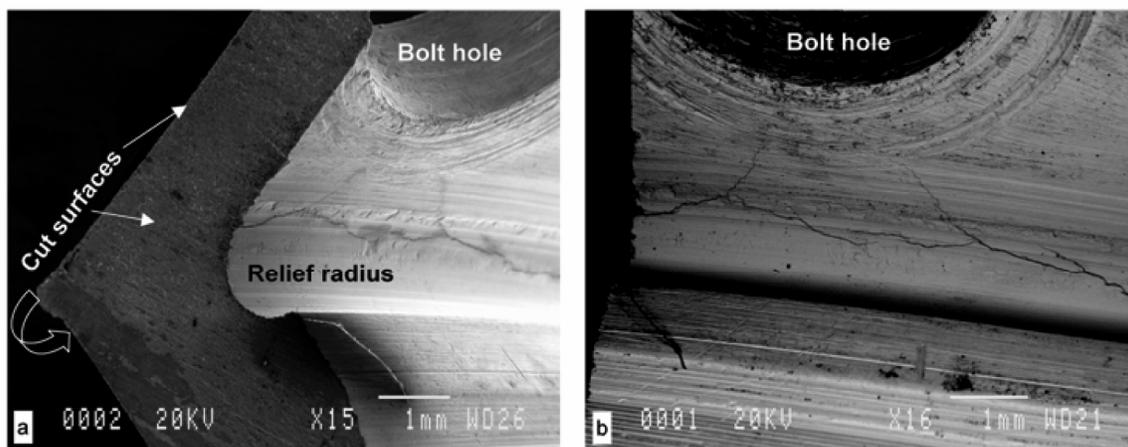
Figure 40.—Relief radius cracking observed in section of S/N 120 near bolt hole J. (a) Low magnification image showing proximity of relief radius to bolt hole. (b) Multiple cracks observed in relief radius.

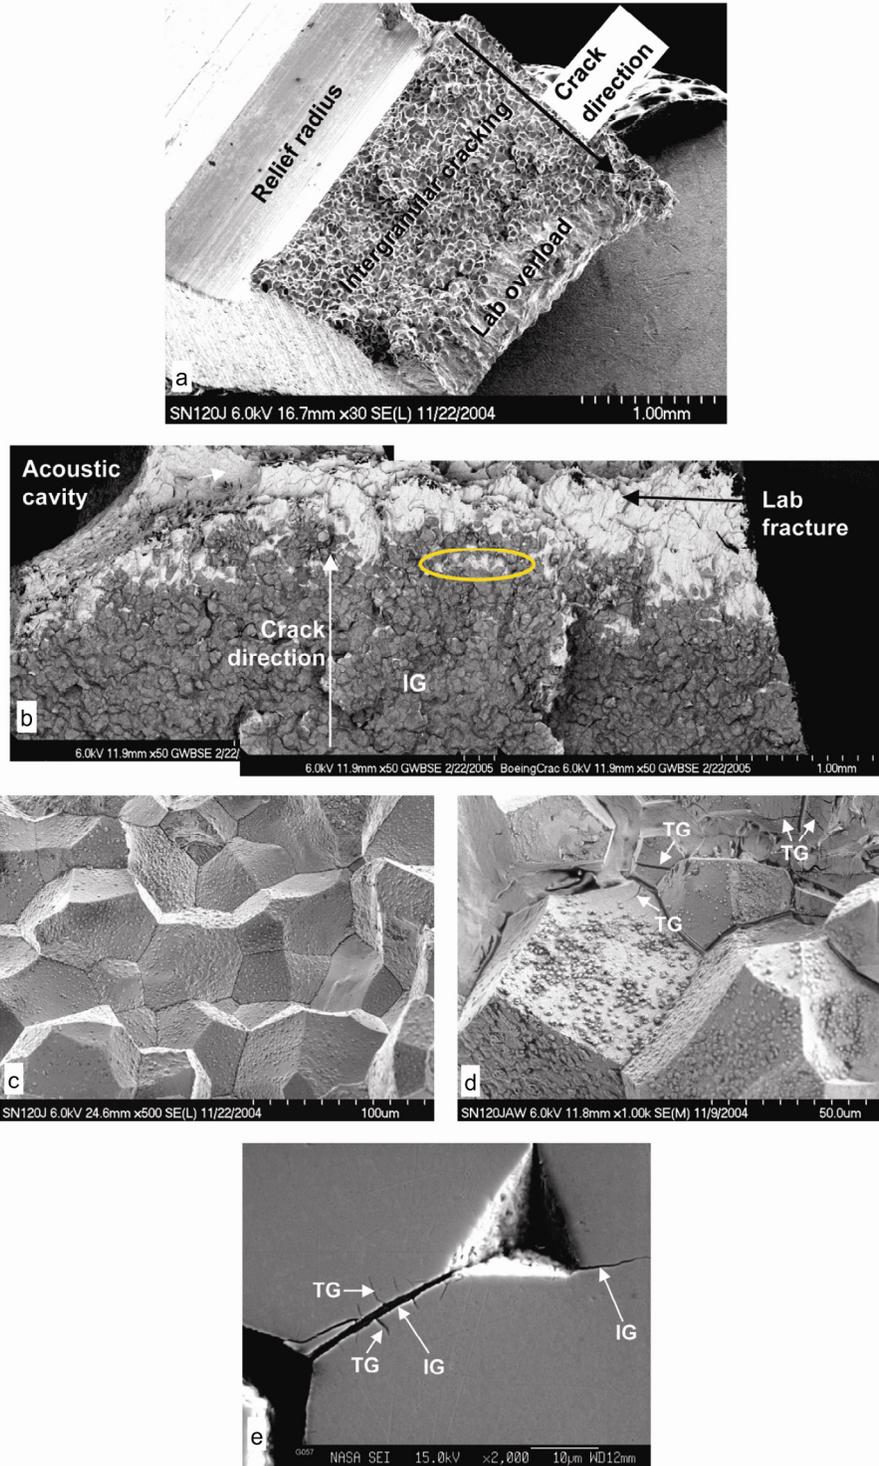
Figure 41.—(a) Overall view showing relief radius, intergranular (IG) cracking, and lab overload area for small section of S/N 120 between bolt holes I and J. (b) Montage of backscattered electron images for another section of S/N 120 having a deeper IG crack between bolt holes J and K. Relief radius is not shown in montage. (c) Higher magnification view showing IG and products on fracture surface. (d) Products are evident on some grain facets of the predominantly IG fracture. Examples of transgranular cracking (TG) were also observed and are indicated by the white arrows. (e) TG was also evident in polished sections of S/N 120, which demonstrates that their presence was not associated with lab openings of fracture surfaces.

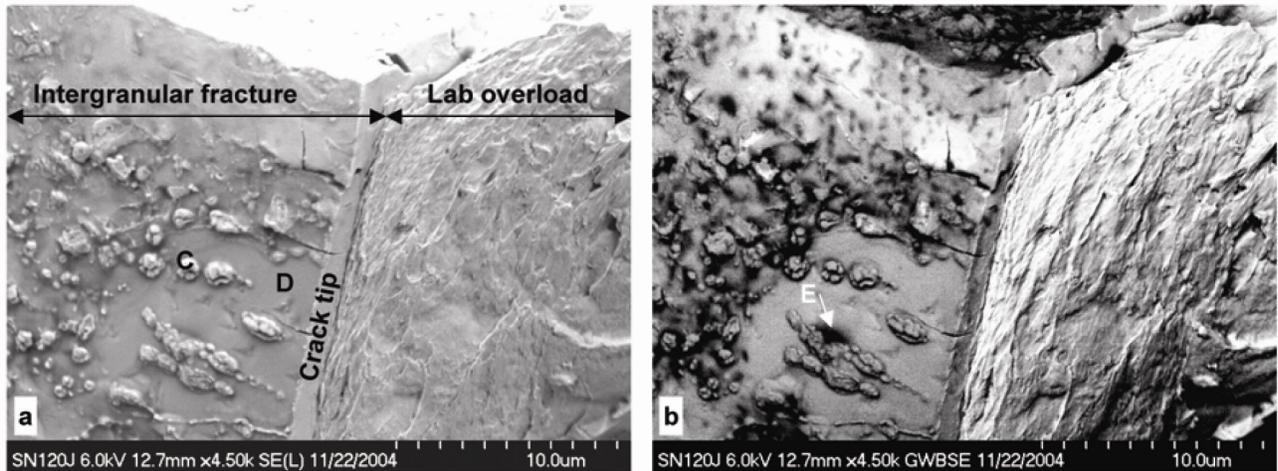
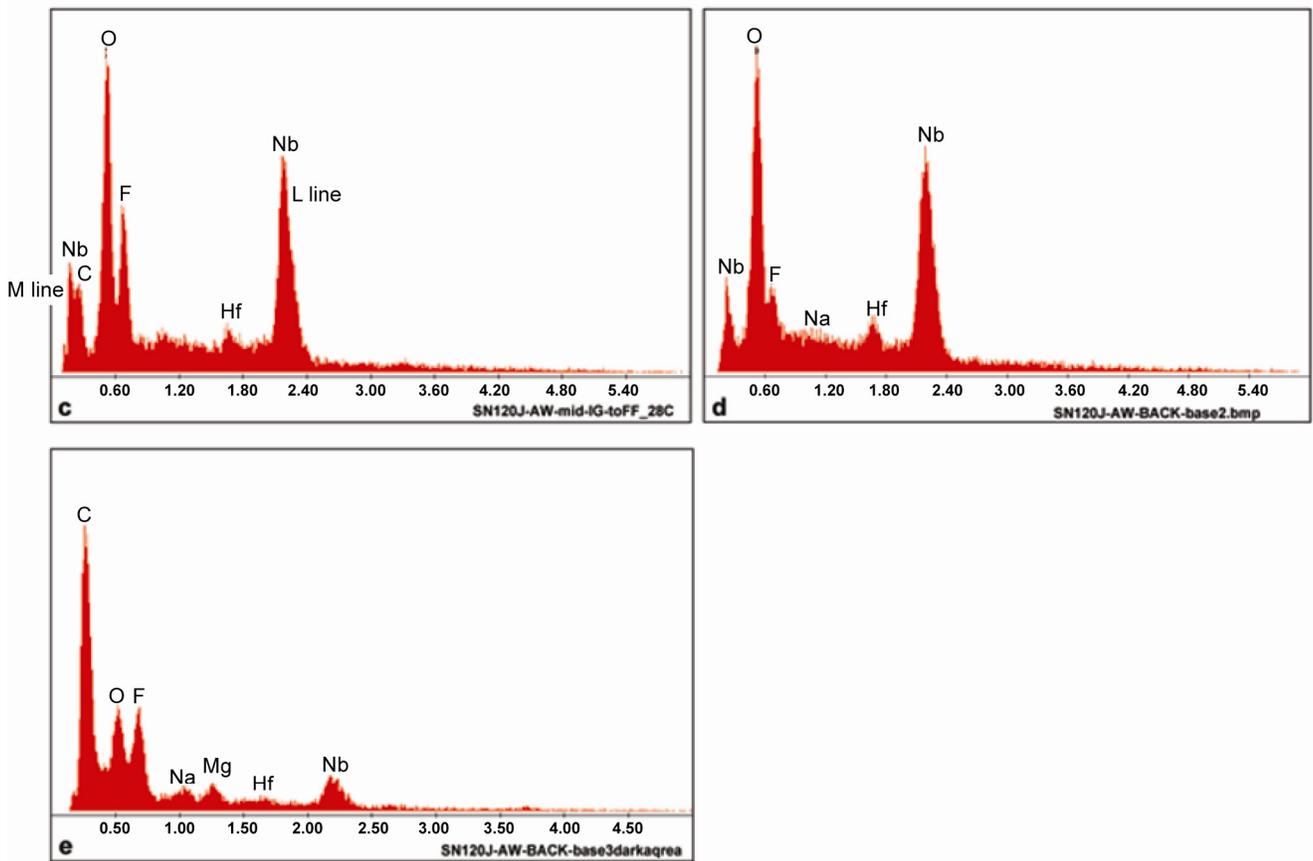
Figure 42.—S/N 120 fracture surface at the tip of the intergranular relief radius crack between bolt holes I and J. Lab overload region is also shown. Reaction products and possible contaminants are evident on the fracture surface. (a) Secondary electron image showing selected areas C and D for Energy Dispersive Spectroscopy (EDS) scans. (b) Backscattered electron image of the same region showing atomic number differences of the features present; darker regions contain lower atomic number elements. Selected area E is shown for EDS scan. Representative EDS scans for (c) popcorn, area C; (d) bright region of oxidized crack surface, area D; and (e) dark region on intergranular crack, area E.

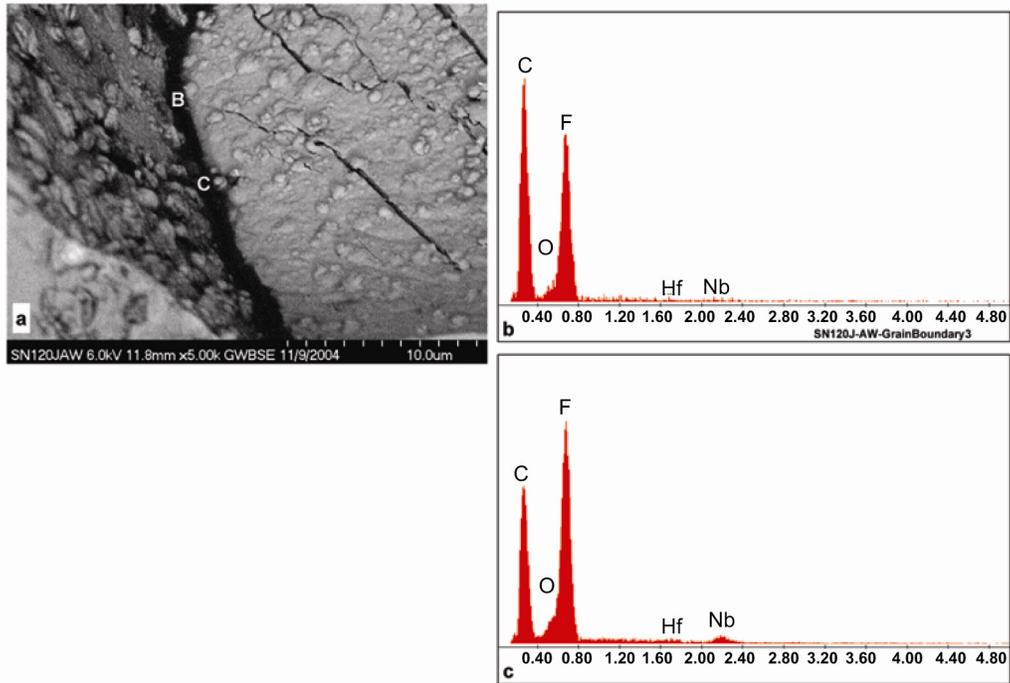
Figure 43.—Carbon and fluorine-rich material was found in numerous dark areas on the S/N 120 fracture surface. (a) Trough along a grain boundary is shown in backscattered electron image. Energy dispersive spectroscopy scans are shown for the dark material in (b) area B and (c) area C.

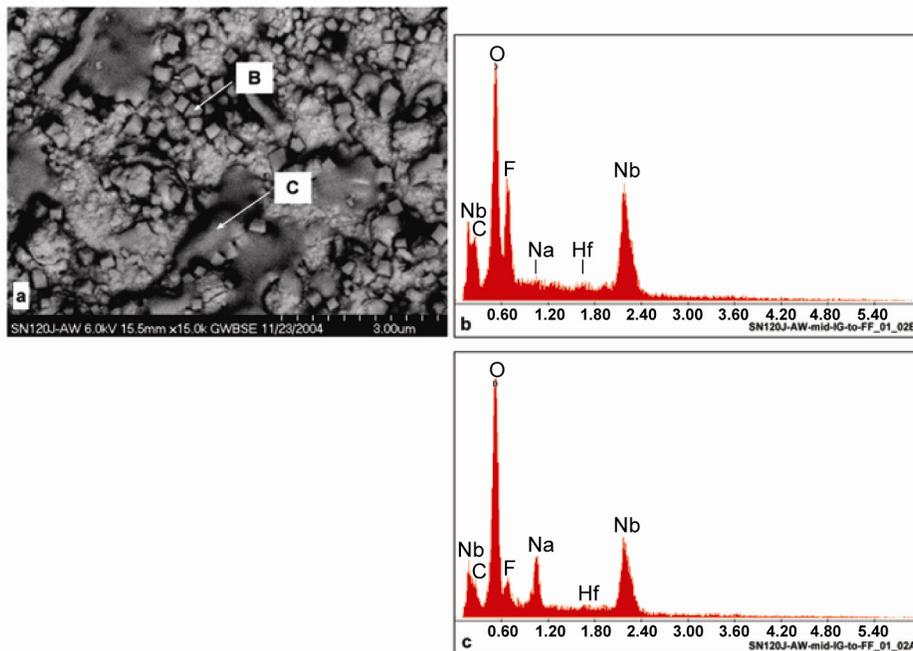
Figure 44.—S/N 120 fracture surface in an isolated region of the crack mouth for relief radius crack between bolt holes I and J. Reaction products and possible contaminants are evident on the fracture surface. (a) Backscattered electron image showing cubic-shaped products at “B” and “mud-flat” areas at “C.” Energy Dispersive Spectroscopy scans are shown for features in (b) area B and (c) area C.

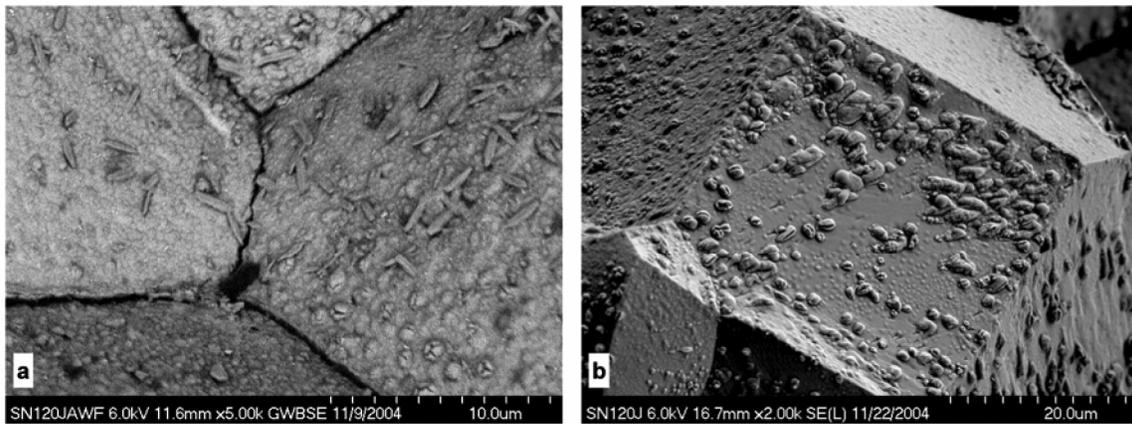
Figure 45.—Intergranular fracture surface from S/N 120 showing (a) acicular products and popcorn-like nodules and (b) popcorn-like nodules, uncracked rounded particles, elongated clusters, and small bumps.

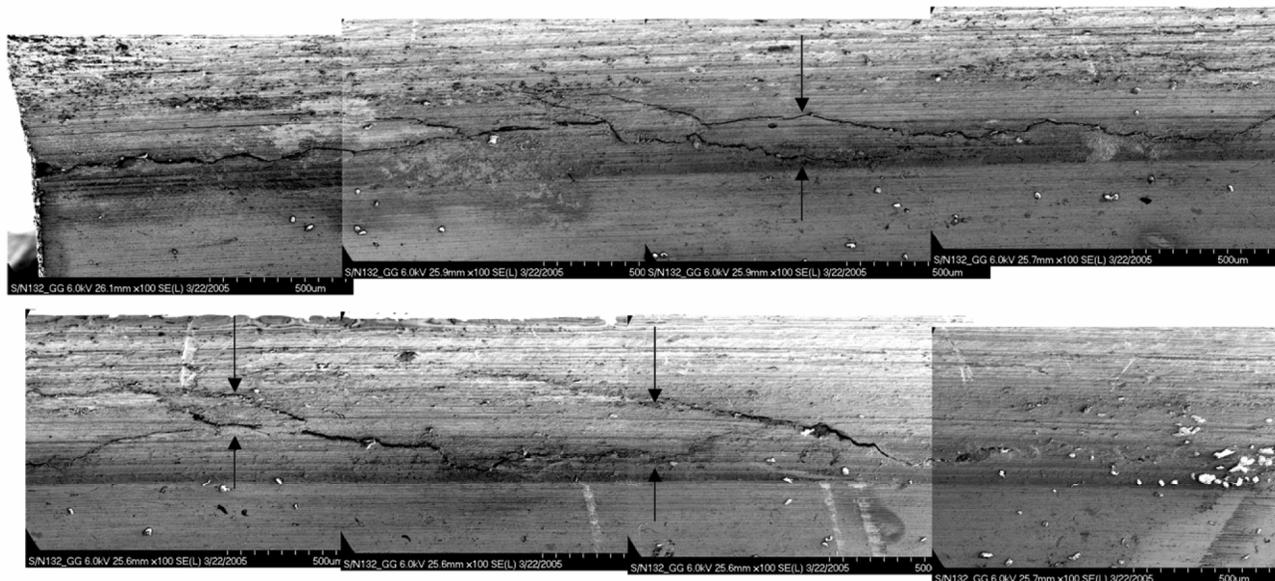
Figure 52.—Montage of scanning electron micrographs showing relief radius cracking in section GG of S/N 132. Multiple crack initiations were frequently observed. Arrows show examples of cracks running parallel to each other; if cross sections were obtained from locations at arrows, then multiple cracks will become evident in those polished cross sections.
